Rail Accident Investigation Branch

Rail Accident Report

**Person struck by a train at Eden Park station,
south-east London
26 February 2020**

Report 01/2021
February 2021

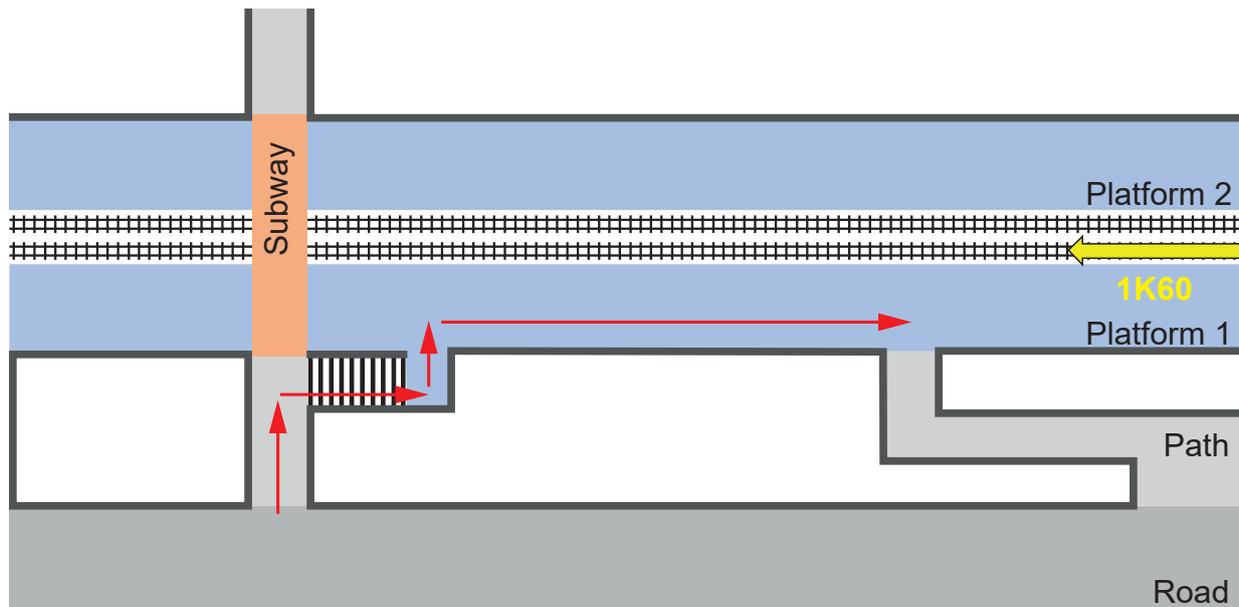
Figure 2: Schematic diagram of person's route to platform 1 (red arrow) within Eden Park station up to around one minute before the accident

- 5 Eden Park station has two platforms with a subway running between them. Platform 1, which is used by trains travelling from Hayes towards London, can be accessed via stairs from the subway or from a ramped path leading up from the station car park (see figure 2). The accident occurred on platform 1 which has a left-hand curve when viewed in the London-bound direction. At the time of the accident the station was unstaffed.

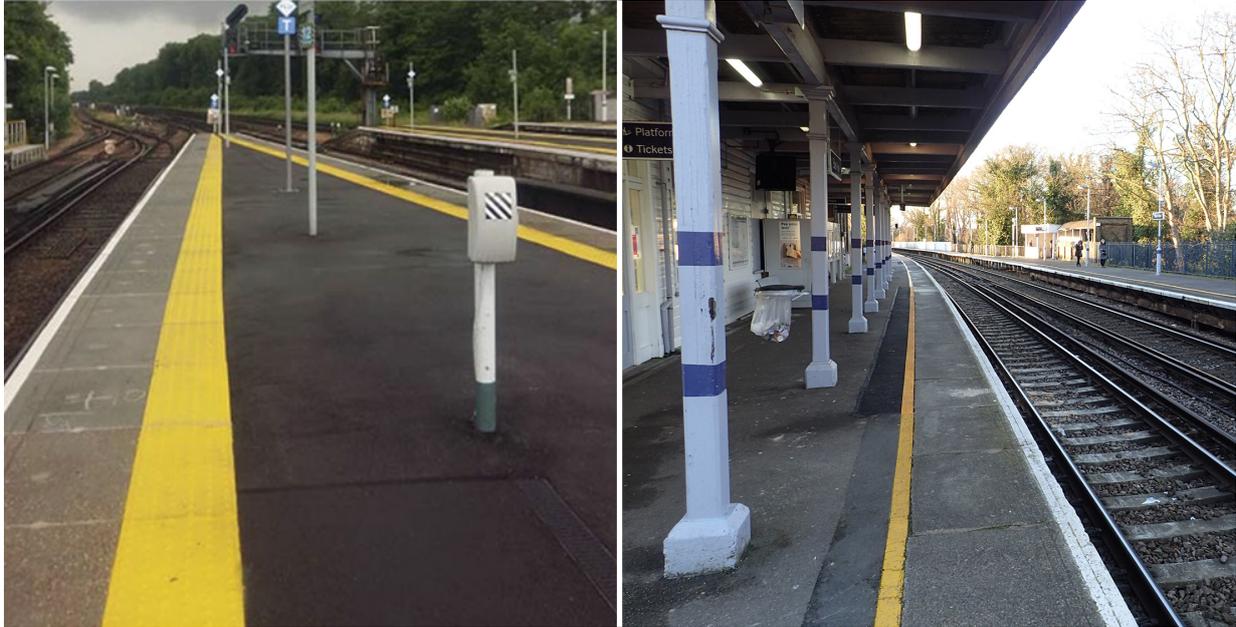
Figure 5: Platforms at Three Bridges station (left) and platform 1 at Eden Park station (right)

- 41 Prior to May 2018, some mainline railway platforms had tactile surfaces painted yellow and installed 760 mm from the platform edge (see figure 5). RSSB research⁷ recommended that this should become standard practice, where possible, to provide a high contrast between the platform surface and the track. The research noted that this contrast is important for both visually impaired people and the general population. Rail Industry Standard RIS-3703-TOM 'Passenger Train Dispatch and Platform Safety Measures' was updated (issue 4) to reflect this recommendation in March 2020.

- 51 The risk assessment noted the condition of platform markings on both platforms and recommended that tactile surfaces should be installed. The PTI risk manager believed that there was a Network Rail programme to install tactile surfaces at all Southeastern Railway's stations before April 2024, and in view of this she took no further action to address this recommendation. After the June 2019 risk assessment, she did not take any interim actions to address the risks associated with the absence of tactile surfaces. She stated that this was because she was unaware of any accident that had occurred on Southeastern Railway managed stations that were attributable to the absence of tactile surfaces at the platform edge.
