Rail Accident Investigation Branch

Rail Accident Report

**Person struck by a train at Eden Park station,
south-east London
26 February 2020**

Report 01/2021
February 2021

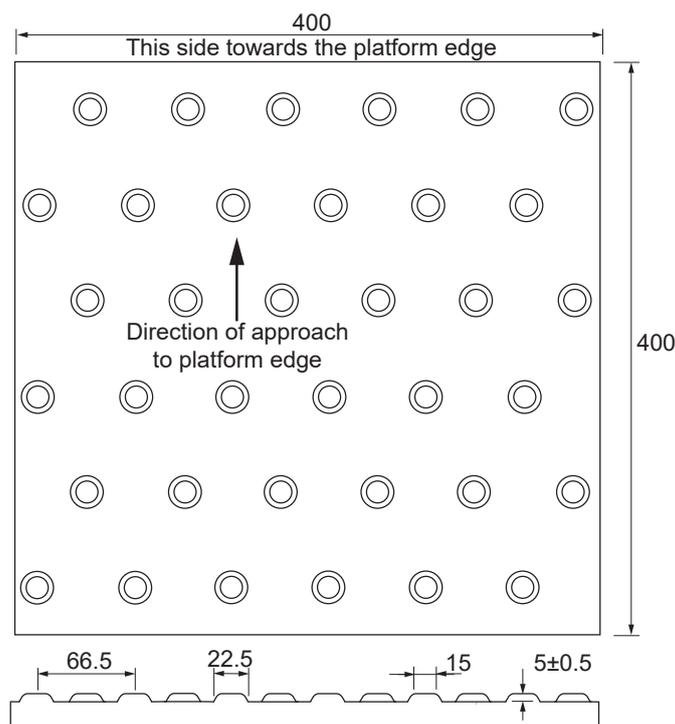
- 40 The DfT guidance requires tactile surfaces for use at the edge of station platforms (referred to as tactile surfaces in the remainder of this report) to be made up of 400 mm squares, each having rows of flat-topped domes (blisters, 22.5 mm outer diameter and 5 mm in height). The blisters are spaced at intervals of 66.5 mm and each row is off-set so a blister in the second row will appear halfway between blisters in the first row (figure 4). The guidance required the whole surface to be more than 500 mm from the platform edge, and of a colour that would provide a good contrast with the platform surface.

Figure 4: Profile and plan view of tactile surfaces at mainline stations
